Summary of Part I of the Steorn Tear-Down Thread

The first Tear-Down thread began with a report reviewing the tear-down of Frank's O-Cube, description of test equipment, early test run findings, some speculation that the stair-stepping traces may be indication of the cells exhibiting a Quantum Hall Effect (they are not) and early conclusions that cells were both recharging themselves as claimed by Steorn and were not harvesting energy from the environment.

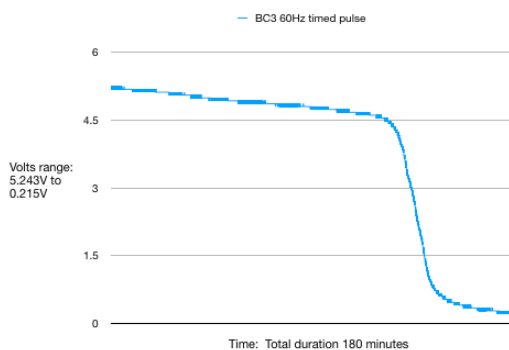
Blue cell discharge profile:

After the cell ramped down linearly, all of a sudden the discharge profile looked much like the hysteresis curve of a magnet going from saturation toward remanence and down through coercivity toward the opposite saturation:

When previously charging the cell to only 1V to 3V I had been capturing only the profile after the cell had begun its steep decline. I had not previously seen the slow ramping down below 5.25V. This demonstrated that for some range of voltages of the blue cells, they were not acting like typical capacitors but possibly were exhibiting indications of being influenced by the actions of magnetic domain alignment, as Steorn had claimed.

Even more interesting, biasing the cell for 8 hours and discharging it versus a quick 10 minute charge showed discharge profiles nearly identical yet still different from that of capacitors. This indicated that the changes in the blue cells were not due to chemical changes, as it might be case with capacitors.

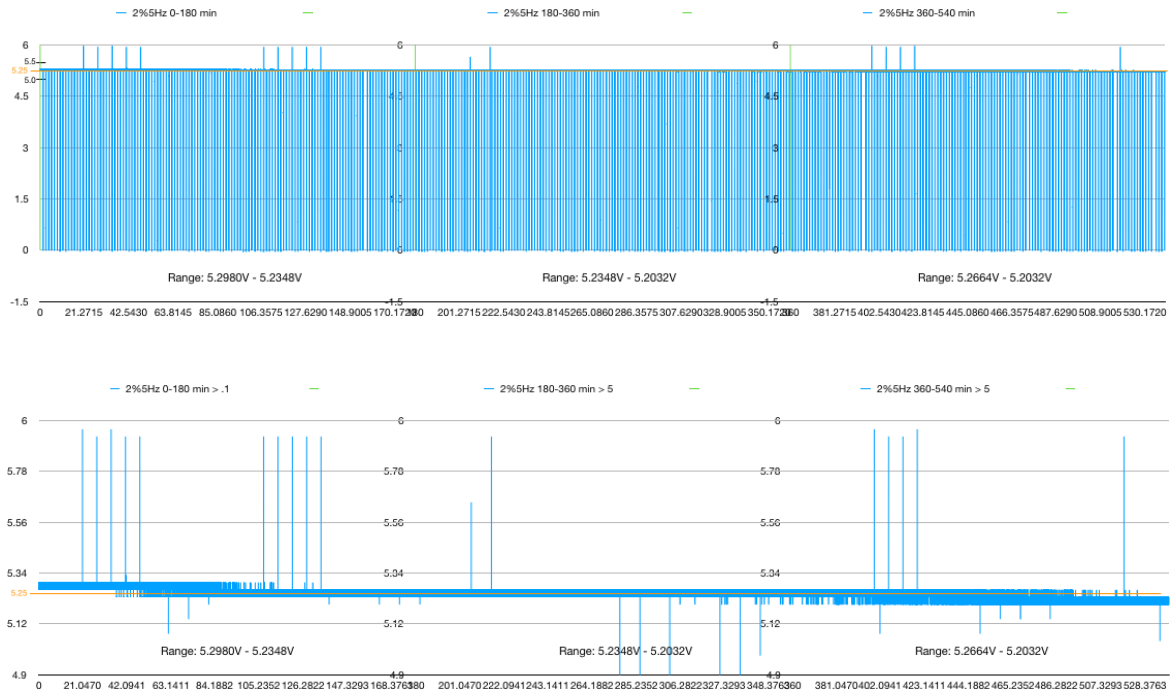
The 9 hour run began with the cell reading at 5.3V after a 3 hour bias. As with the 470 ohm resistor, the results of the 9 hr run show the trace still trending down.

Despite beginning 0.3V higher at the start than the 470 ohm test, this run also moved down to about 5.2V and also showed some large spikes above and below. I'm not sure yet whether those large spikes are artifacts of the recording or not.

The results indicate that I should still go higher in resistance. It was pointed out that the 91K ohm run did dip down 8 hours into the run, but quickly recovered, so I still consider 91K as having reached stability, so my selection from the resistors will still be below 91K.

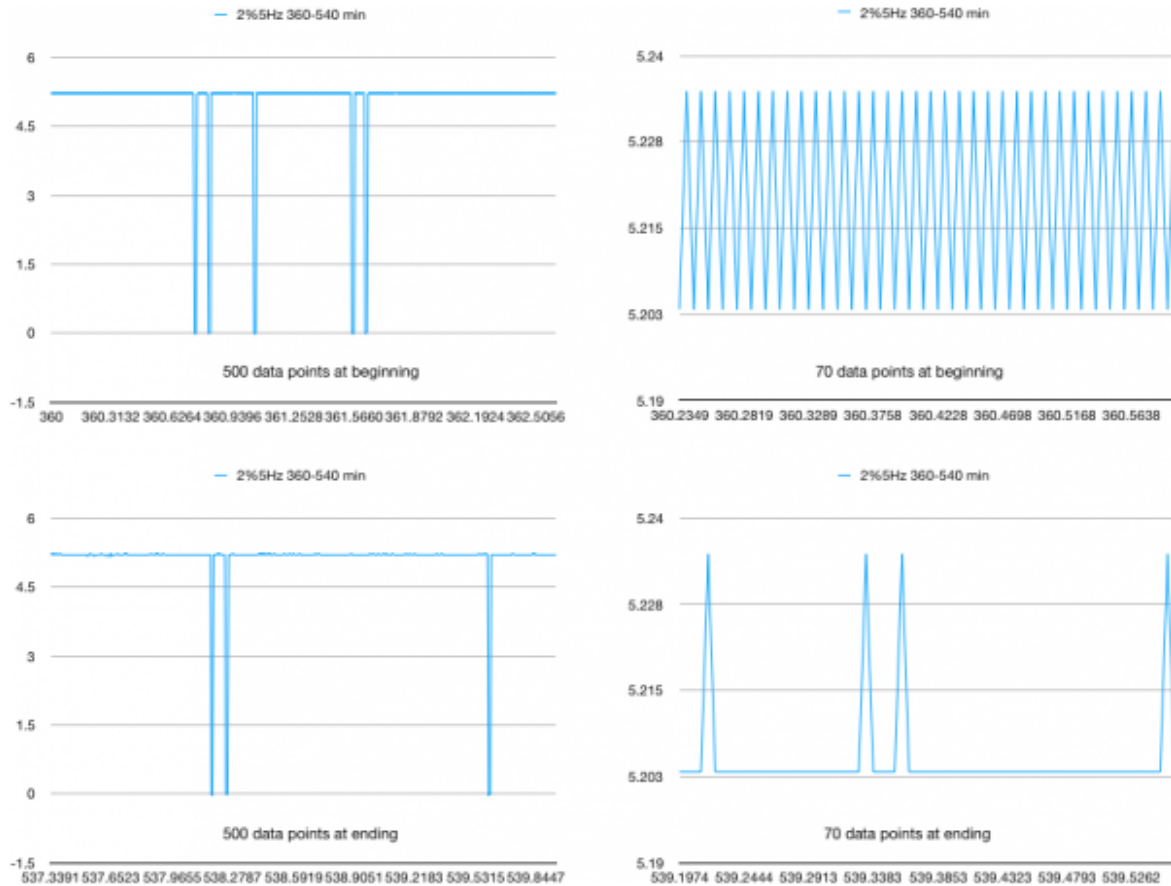
Although it looks like the trace is pretty stable at the end of the run, a look at a closeup of the first 500/70 data points and the last 500/70 data points shows that the trend of the trace is still going down:

So this indicates that moving to a higher ohm values still well under 1K ohm moves us closer to stability (other variables being held steady), but it is not being reached. The next step up in my resistor kit is 15K ohm, so I need to get some other resistors between 500 ohm and 15K ohm. Will be back at it later today.

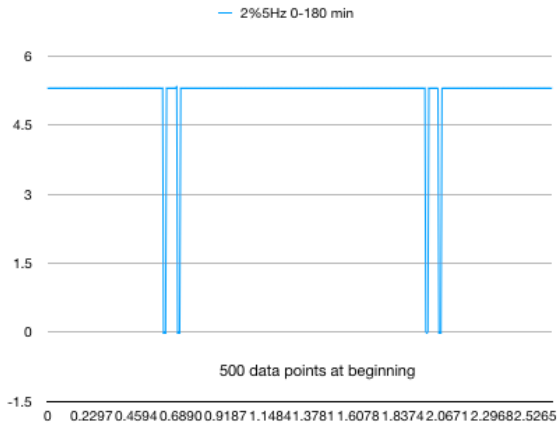
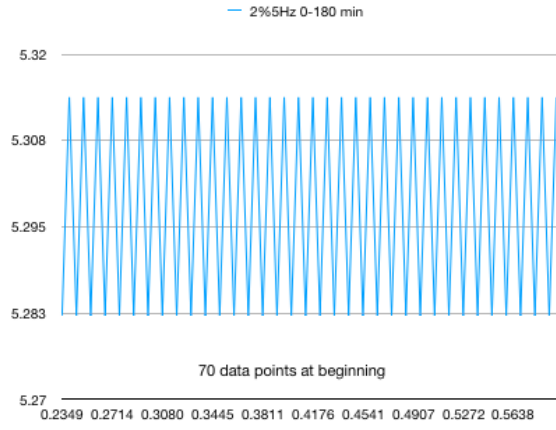
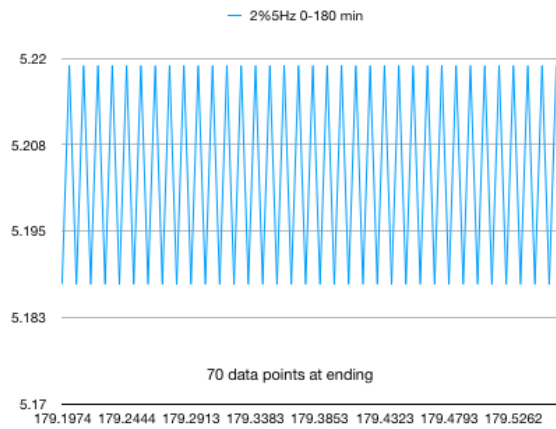
The traces are not just oscillating between the resolution of the scope at those setting. Here is a sample of the first 3 hours when the draining resistor was 91.6 ohm:

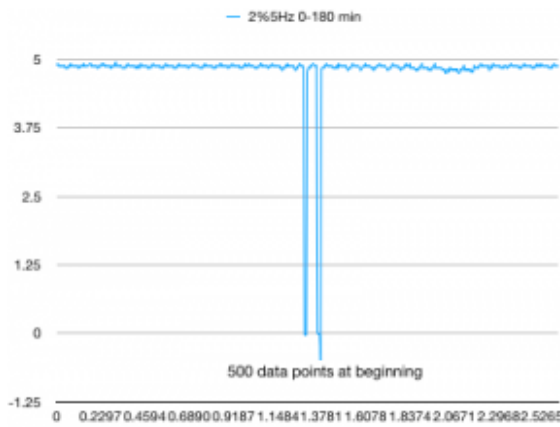
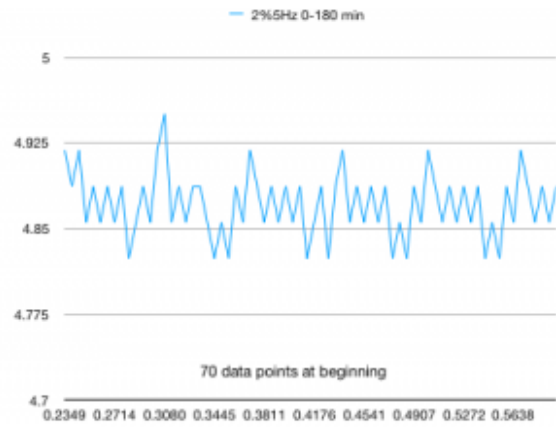
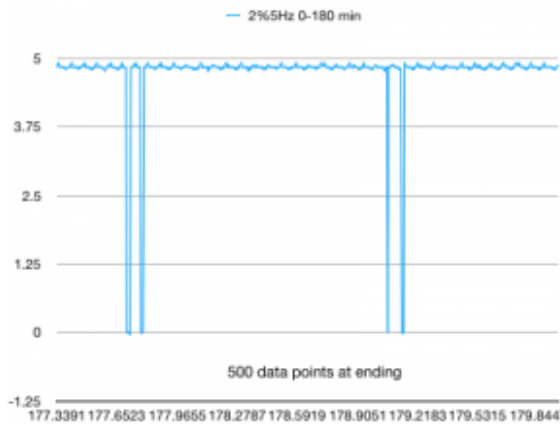
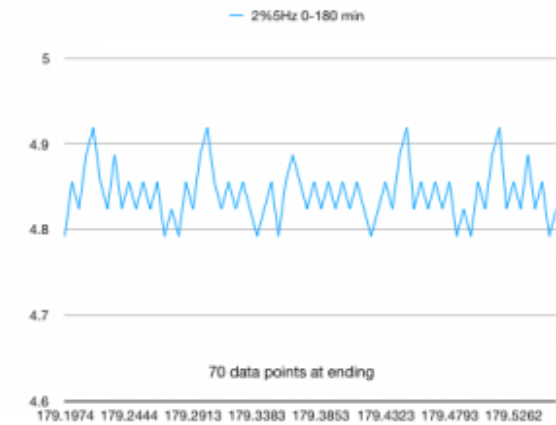
And here is the sample of the first 3 hours when the draining resistor was 91K ohm:
